**DEPARTMENT OF TRANSPORTATION****DIVISION OF ENGINEERING SERVICES**

Contract #: 04-0120F4Cty: SF/ALA Rte: 80 PM: 13.2/13.9File #: 99.28**WELDING INSPECTION REPORT****Resident Engineer:**Pursell, Gary**Address:** 333 Burma Road**City:** Oakland, CA 94607**Report No:** WIR-002680**Date Inspected:** 20-May-2008**Project Name:** SAS Superstructure**OSM Arrival Time:** 830**Prime Contractor:** American Bridge/Fluor Enterprises, a JV**OSM Departure Time:** 1830**Contractor:** Japan Steel Works, Ltd.**Location:** Muroran, Japan**CWI Name:** C. Fu-Kuan**CWI Present:** Yes No**Inspected CWI report:** Yes No N/A**Rod Oven in Use:** Yes No N/A**Electrode to specification:** Yes No N/A**Weld Procedures Followed:** Yes No N/A**Qualified Welders:** Yes No N/A**Verified Joint Fit-up:** Yes No N/A**Approved Drawings:** Yes No N/A**Approved WPS:** Yes No N/A**Delayed / Cancelled:** Yes No N/A**Bridge No:** 34-0006**Component:** Tower, Jacking and Deviation Saddles**Summary of Items Observed:**

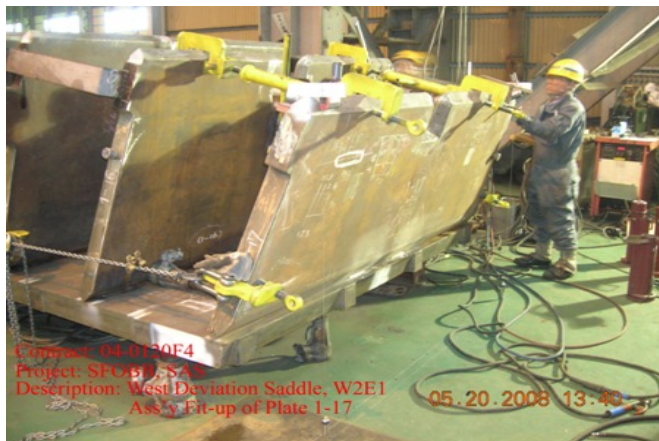
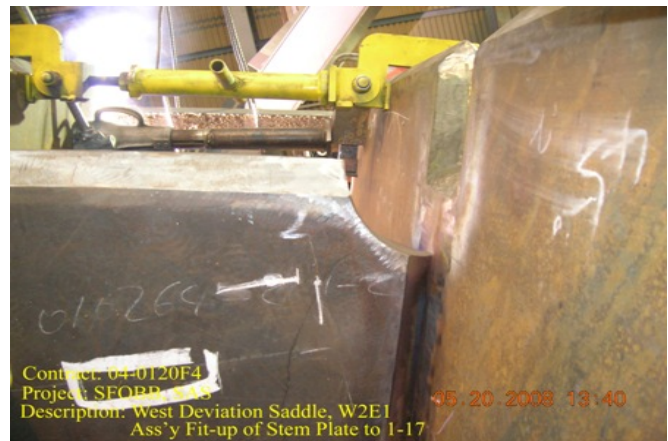
At approximately 08:30 hours, this QA inspector traveled to the Fabrication Shop # 4 without a Japan Steel Works, Ltd. (JSW) escort to observe the continued assembly fit-up operation of the structural steel plates for the West Deviation Saddle W2E1. Upon the arrival at the Fabrication Shop, this QA inspector observed the Quality Control (QC) Inspector Chung Fu-Kuan performing a visual inspection of the tack welds on the Rib Plates 6U, 6L and 7L. There were no discrepancies noted by Chung Fu-Kuan at the conclusion of the QC visual inspection.

Later in the shift this QA inspector observed the JSW assembly fit-up personnel Koanagi-Kiyotaka performing the fit-up task of the structural steel plate component identified as 1-17 with the following corresponding weld numbers; E1Y-17V, E1Y-17L-2 and E1Y-17I-1. At the conclusion of the alignment of 1-17 to the stem plate and base plate, Ohta-Yoshihiro ID 08-2017 performed the tack welding utilizing the Shielded Metal Arc Welding (SMAW) as per the Welding Procedure Specification (WPS) SJ-3011-11. The WPS was also used by the QC inspector Chung Fu-Kuan as a reference during QC verification. At the conclusion of the tack welding Chung Fu-Kuan performed a visual inspection and found a cracked tack weld at the weld identified as E1Y-17-V. This QA inspector concurs with the QC inspector's assessment and this QA inspector also observed Chung Fu-Kuan entering this data into the QC inspector's daily log and identifying the location on a weld map. The repair will be scheduled at a later date.

The following digital photographs illustrate the observations of the activities performed on this date.
